INFORME DEL COMPORTAMIENTO DE LA LADERA DERECHA DE LA PRESA DE YESA (NAVARRA). NOVIEMBRE 2017

Zaragoza, diciembre de 2017

Confederación Hidrográfica del Ebro.

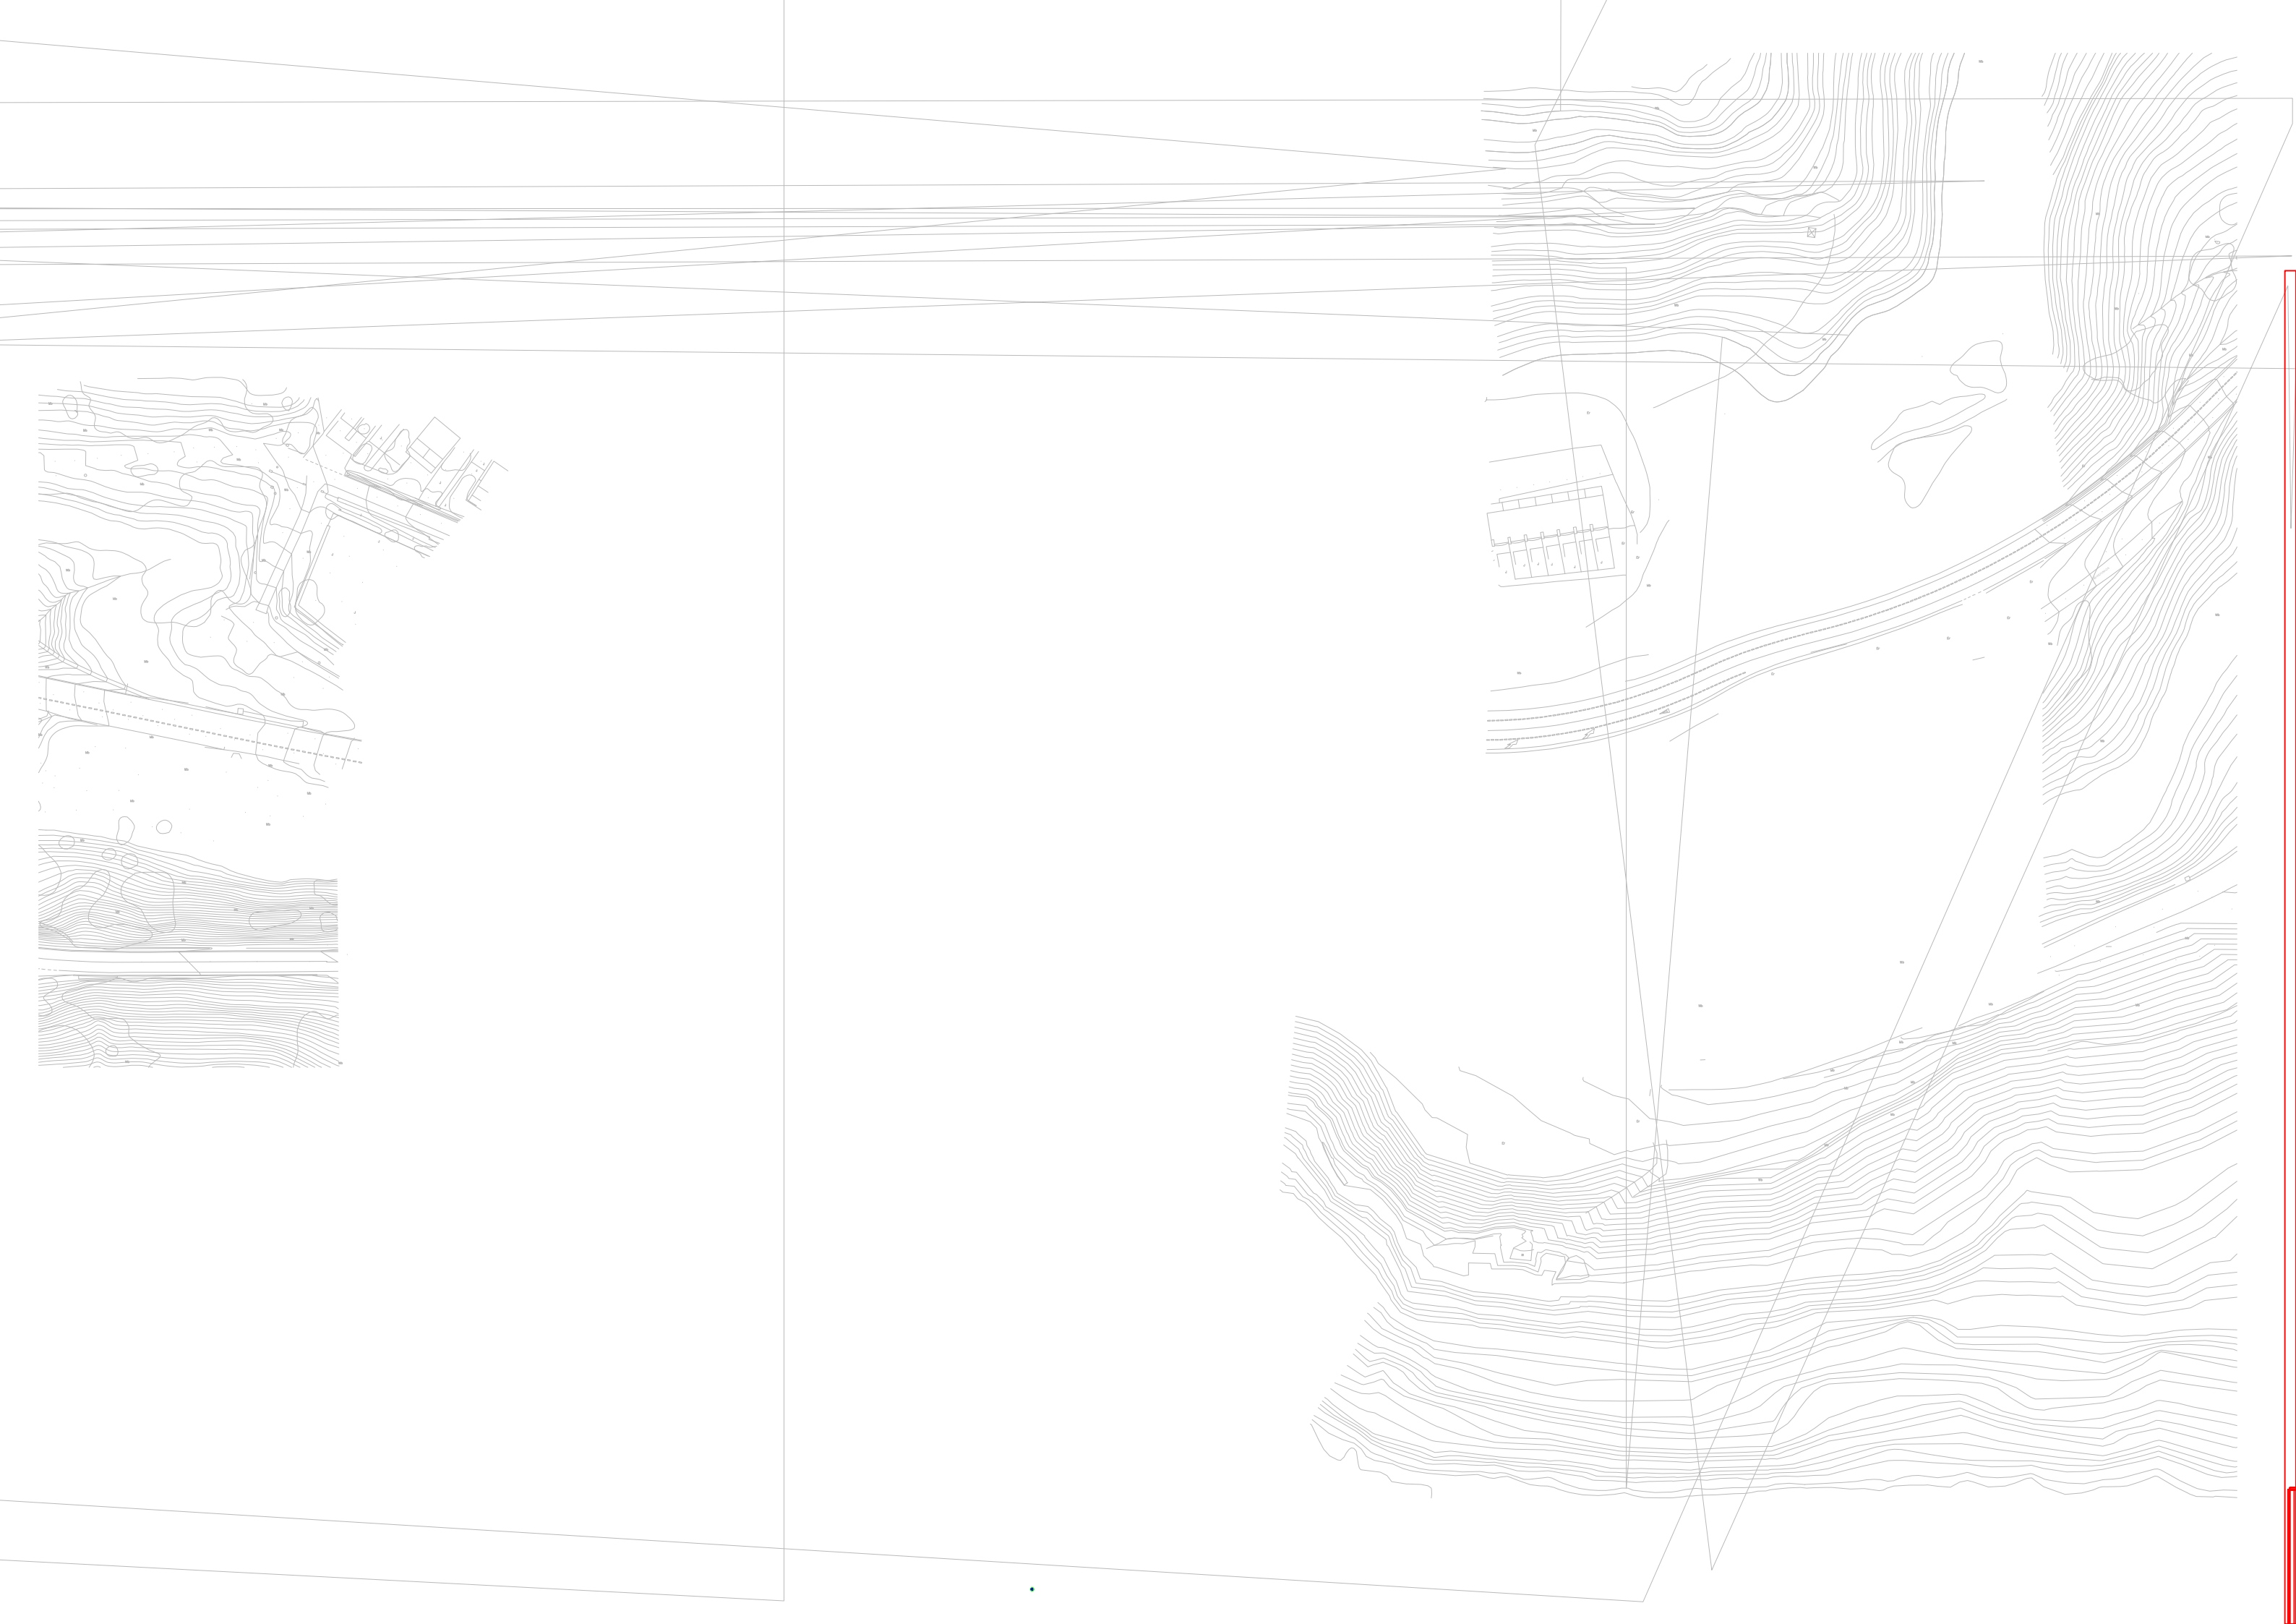
ANEJO Nº 1:
Plano de movimiento de los Puntos de Control Topográfico.

En ambas representaciones se comprueba que el movimiento es insignificante.
